# **Summary of NHCP Undertakings for the Maintenance and Conservation of San Agustin Church in Paoay, Ilocos Norte**

**REYNALDO A. INOVERO**

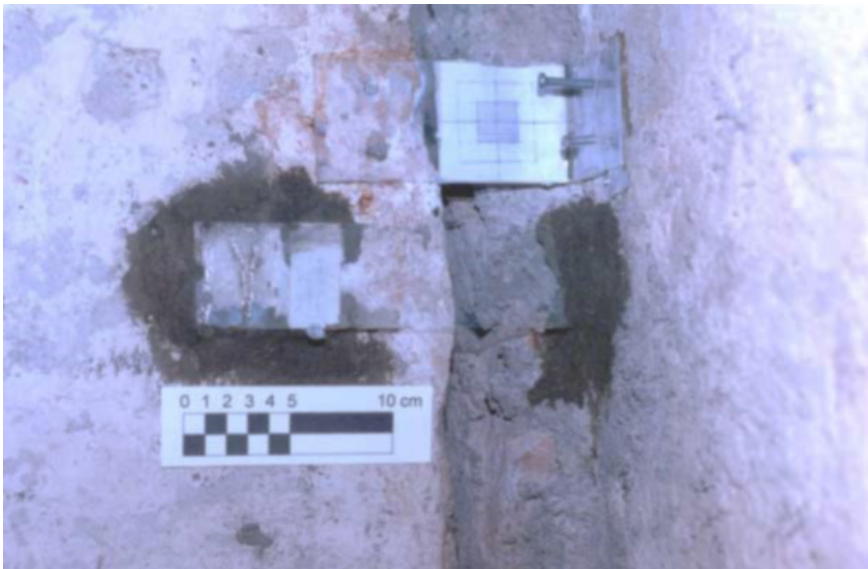
Telltale crack monitoring device (NHCP-HPD photo collection)

In order to find out if small ground movements really affect the church structure, in 2001, the NHI installed telltale crack monitoring devices at strategic places across cracks in the walls. For about a period of one year, NHI architects and engineers visited and monitored these devices, and did not see any significant movement or change in the markings. This was a good indication that the church structure and foundation were still stable during that time.

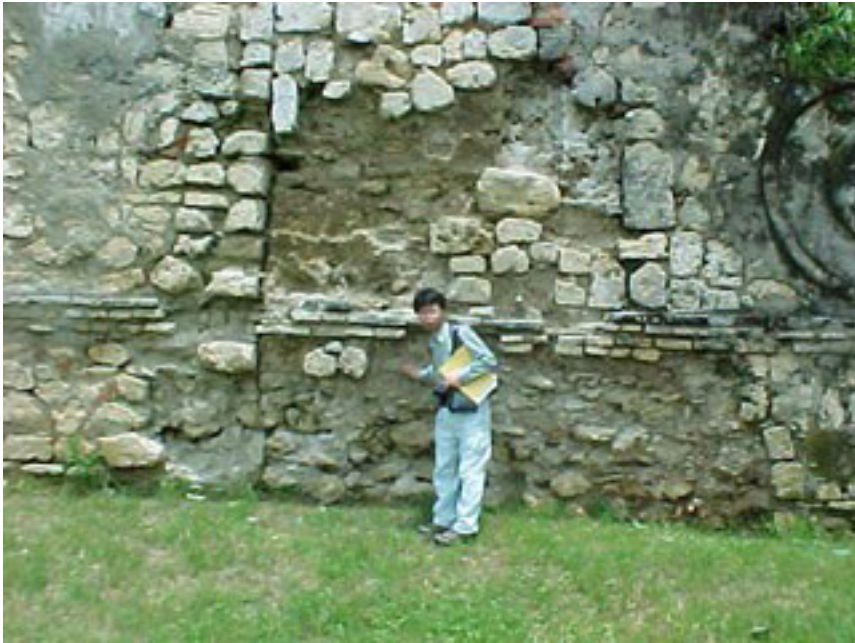
Dr. Hanazato inspecting damaged wall of Paoay Church  
(NHCP-HPD photo collection)

In July 2000, the Reactive Monitoring Mission of Dr. Toshikazu Hanazato, in connection with the preservation and restoration of Paoay Church, was undertaken. Dr. Hanazato undertook seismic analysis with the assistance of engineers from the Philippine Institute of Volcanology and Seismology (Phivolcs). Two architects from the HPD participated in the technical survey and documentation of the existing structures for the use of Dr. Hanazato in his investigative studies, feedback report, and recommendations to Philippine authorities. The HPD architects were assigned to make a condition mapping of the wall materials and damage/deterioration, and to prepare an illustration of the wall cross sections to show the typical wall construction methods.

A copy of the completed detailed engineering studies (DES) was given to the NHCP. The report and recommendations of Dr. Hanazato were incorporated in the DES and drawings submitted to the NCCA. In his report, Dr. Hanazato emphasized the effect of micro tremors on the church foundation. As a result, vehicular traffic near the church was restricted, and some roads leading to the church were closed. This decision was not totally favored by majority of Paoay residents and churchgoers. Roads were reopened later as appealed by the residents.

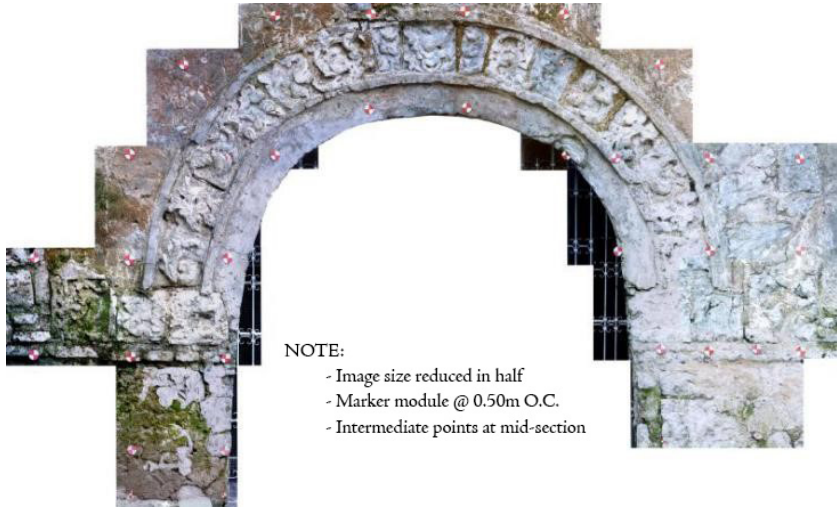
Rectified photograph showing details and amount of deterioration for scientific study use (NHCP-HPD photo collection)

In 2002, the NHI-HPD developed its own rectified photography techniques in producing photographic and graphic hybrid representation of historic buildings to enhance the scientific studies for all heritage objects.
