# **Material and Property Characterization of Eight Heritage Churches Declared as National Cultural Treasures**

**LIE ZAR L. MONTILLA**

## **ABSTRACT**

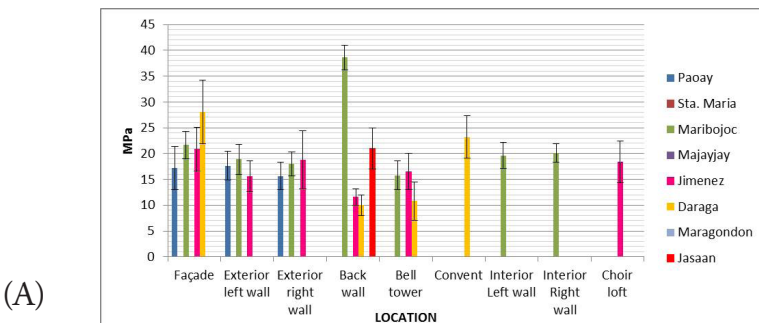
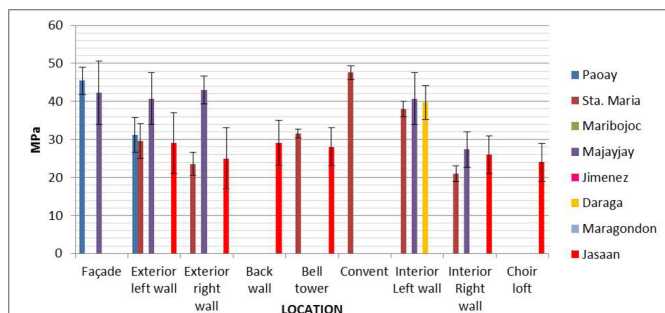
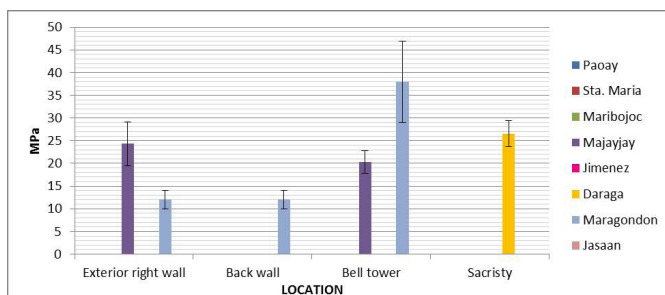
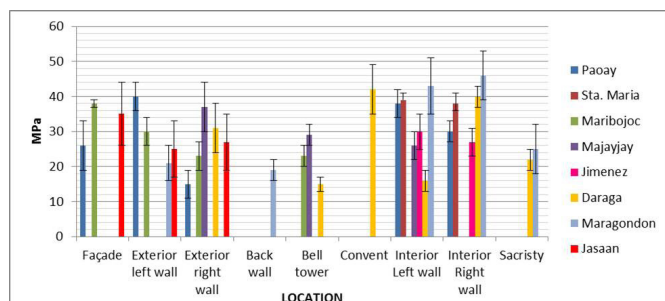
Figure 3. Compressive strength of coral (A), bricks (B), adobe (C), and plaster (D) measured at different points in the exterior and interior location points

Corals used as stone blocks were found to have a normal range of compressive strength from 13 Mpa to 25 MPa. Critical areas as well as high variations in data were found on the blocks from the back wall of Jimenez Church (12 MPa) and Daraga Church (10 MPa); meanwhile the highest strength was also found on the back wall, except for Maribojoc Church (39 MPa).

Bricks exhibited higher compressive strength than coral blocks as building materials. Bricks were found to have a normal range of compressive strength of 25 MPa to 41 MPa. Critical areas were identified on the interior walls of the Santa Maria Church (21 MPa) and Jasaan Church (24 MPa). High variations in data were observed on bricks from Majayjay Church and Jasaan Church.

Compressive strength analysis of adobe was conducted only on Majayjay, Maragondon, and Daraga churches. Average compressive strength of tested adobe materials was 22 MPa. Adobe materials on the exterior walls of Maragondon Church were critical, while those found on the bell tower were of stable condition.

Generally, plaster from the interior walls of the churches tested was found to have relatively higher strength than that from the exterior walls. Critical areas include Paoay Church's exterior right wall (15 MPa), interior left wall (15 MPa), and exterior bell tower walls (16 MPa). The plaster compressive strength of the following location points was found to have significantly higher readings than the corresponding building materials underneath (exterior left wall of Paoay Church, underneath coral and bricks; interior right wall of Santa Maria Church, underneath bricks; all exterior walls of Maribojoc Church, underneath corals; exterior right wall and bell tower walls of Majayjay Church, underneath adobe; interior walls of the church and convent walls from the Daraga Church, underneath corals; and facade of Jasaan Church, underneath bricks).

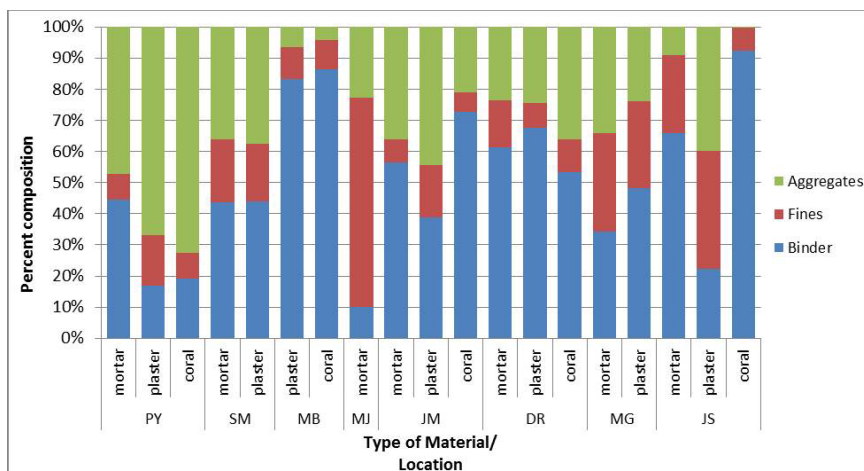
Figure 5. Binder aggregate composition of representative samples

Plaster exhibited less binder composition than the corresponding mortar in Paoay, Jimenez, and Jasaan churches, while the opposite was observed in Maragondon Church. Equal proportions of binder were observed on mortar and plaster from Santa Maria and Daraga (DR) churches. Coral, as expected, contained the most amount of binder; however, low amount of binder was observed from those retrieved from Paoay and Daraga churches.
